Sodium Freezing and Remelting Tests in FY 2018

Nuclear Science and Engineering Division

Q. Lv, Y. Momozaki, E. Boron, D. B. Chojnowski, J. J. Sienicki, and C. B. Reed
Nuclear Science and Engineering Division, Argonne National Laboratory

September 27, 2018

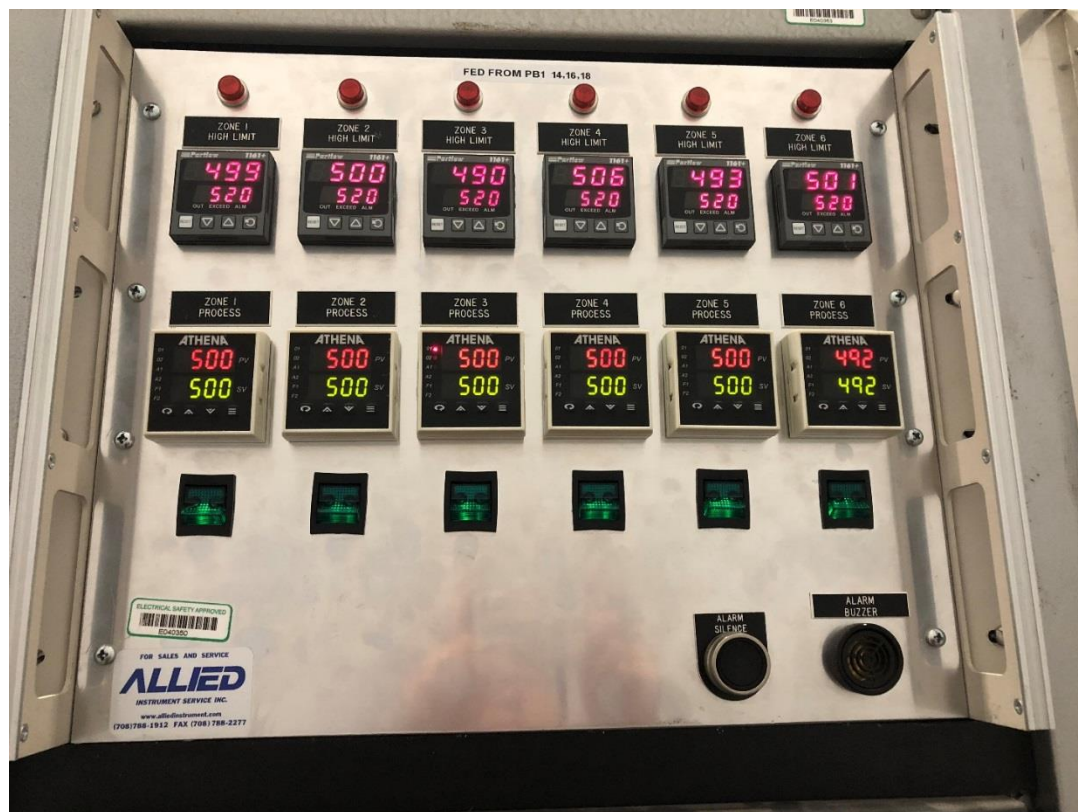
Figure 17. Heater set temperatures in the test section in Test 3.

The same steps up to the point of initiating sodium flow as performed in Test 2 were first carried out in Test 3. After confirming the sodium flow, the system temperatures were raised slowly until the test section set temperatures reached 500°C, as shown in Figure 17. Since the cold finger was not used for the wetting test, the temperatures in the rest of the loop were deliberately set at lower values, as shown in Figure 18, so that impurities would not deposit in the test section.

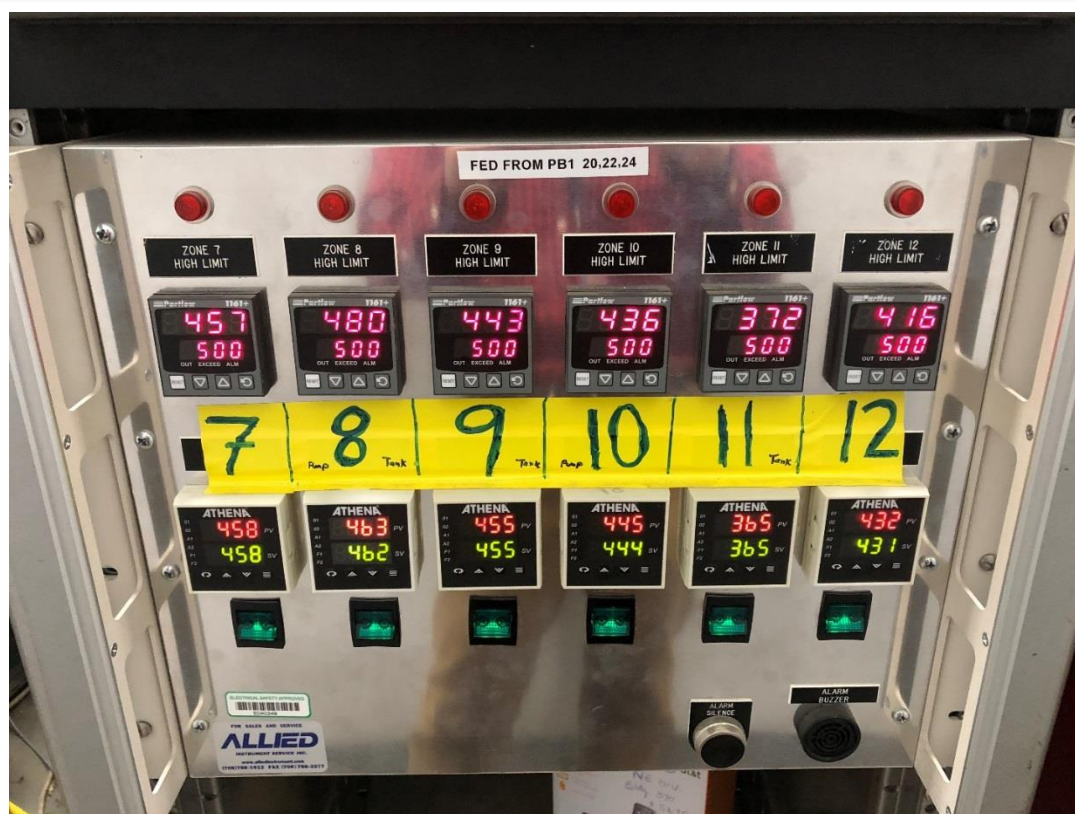
Figure 18. Heater set temperatures in the rest of the loop in Test 3.

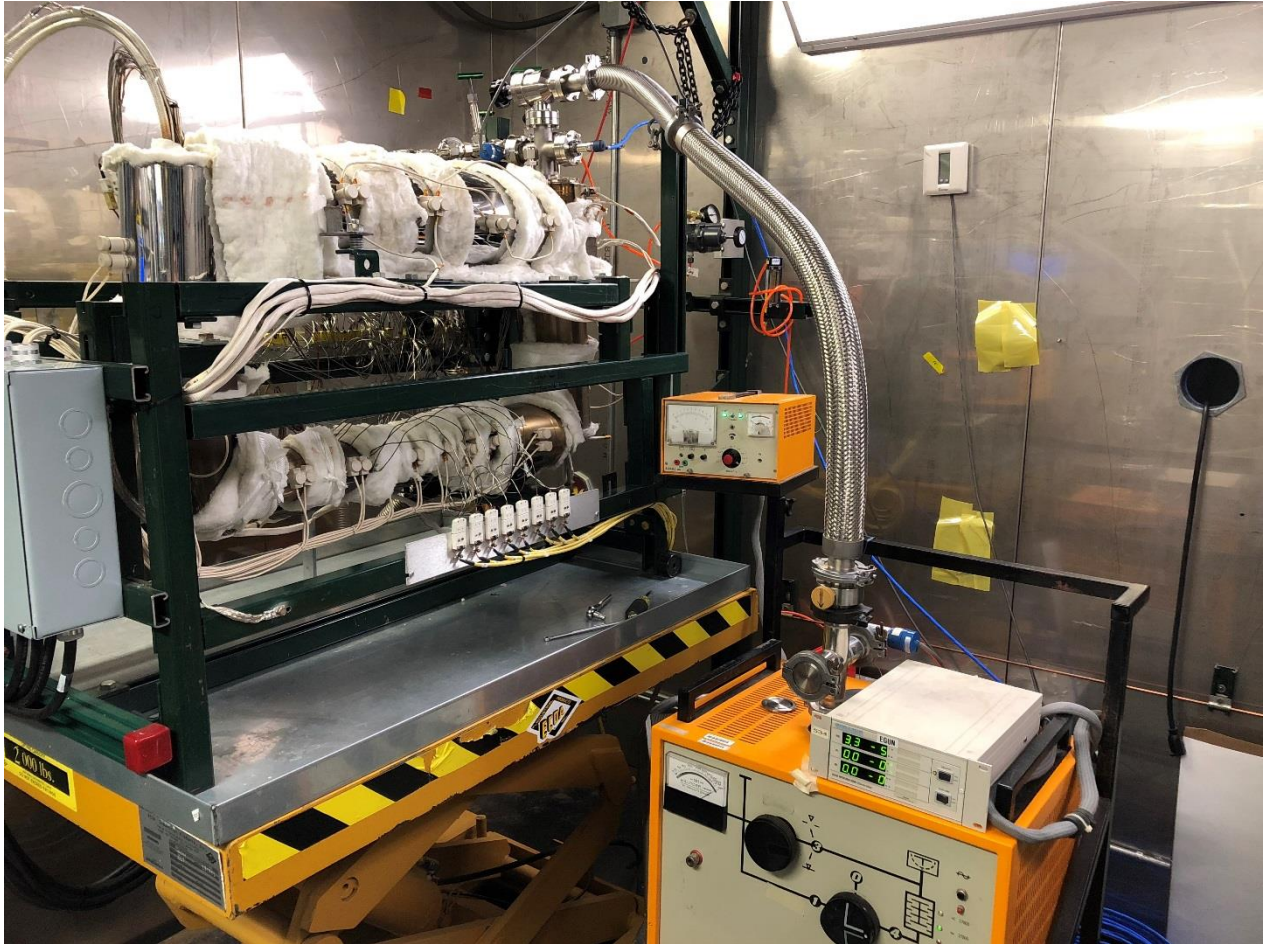
Figure 31. Setup for the vacuum test.

This test was intended to examine the effect of dissolved Ar in the liquid sodium on the freezing phenomena. Before starting the test, modification to the loop was necessary. In place of the cold finger a cross connection was set up, with the bottom port connected to the reservoir, the side ports connected to a vacuum ion gage and a Convectron vacuum gage, and the top port connected to the leak detector through a big port valve. The setup is shown in Figure 31. A quick vacuum was first pulled when the loop was still at room temperature. The loop was then heated up while evacuating the system. During the heatup, slow outgassing was observed through the pressure monitoring system. As heating continued, sodium was melted from the free surfaces. When the sodium in the reservoir started to melt, drastic changes in the pressure reading was observed, which was a clear indication of trapped Ar gas inside of the sodium. Once all the sodium was melted, the EM pump was turned on to circulate the sodium, at which point no drastic change in the pressure reading was observed. The loop was then left to stabilize, with all the temperature controllers set at 105°C, sodium being circulated, and the loop being evacuated.

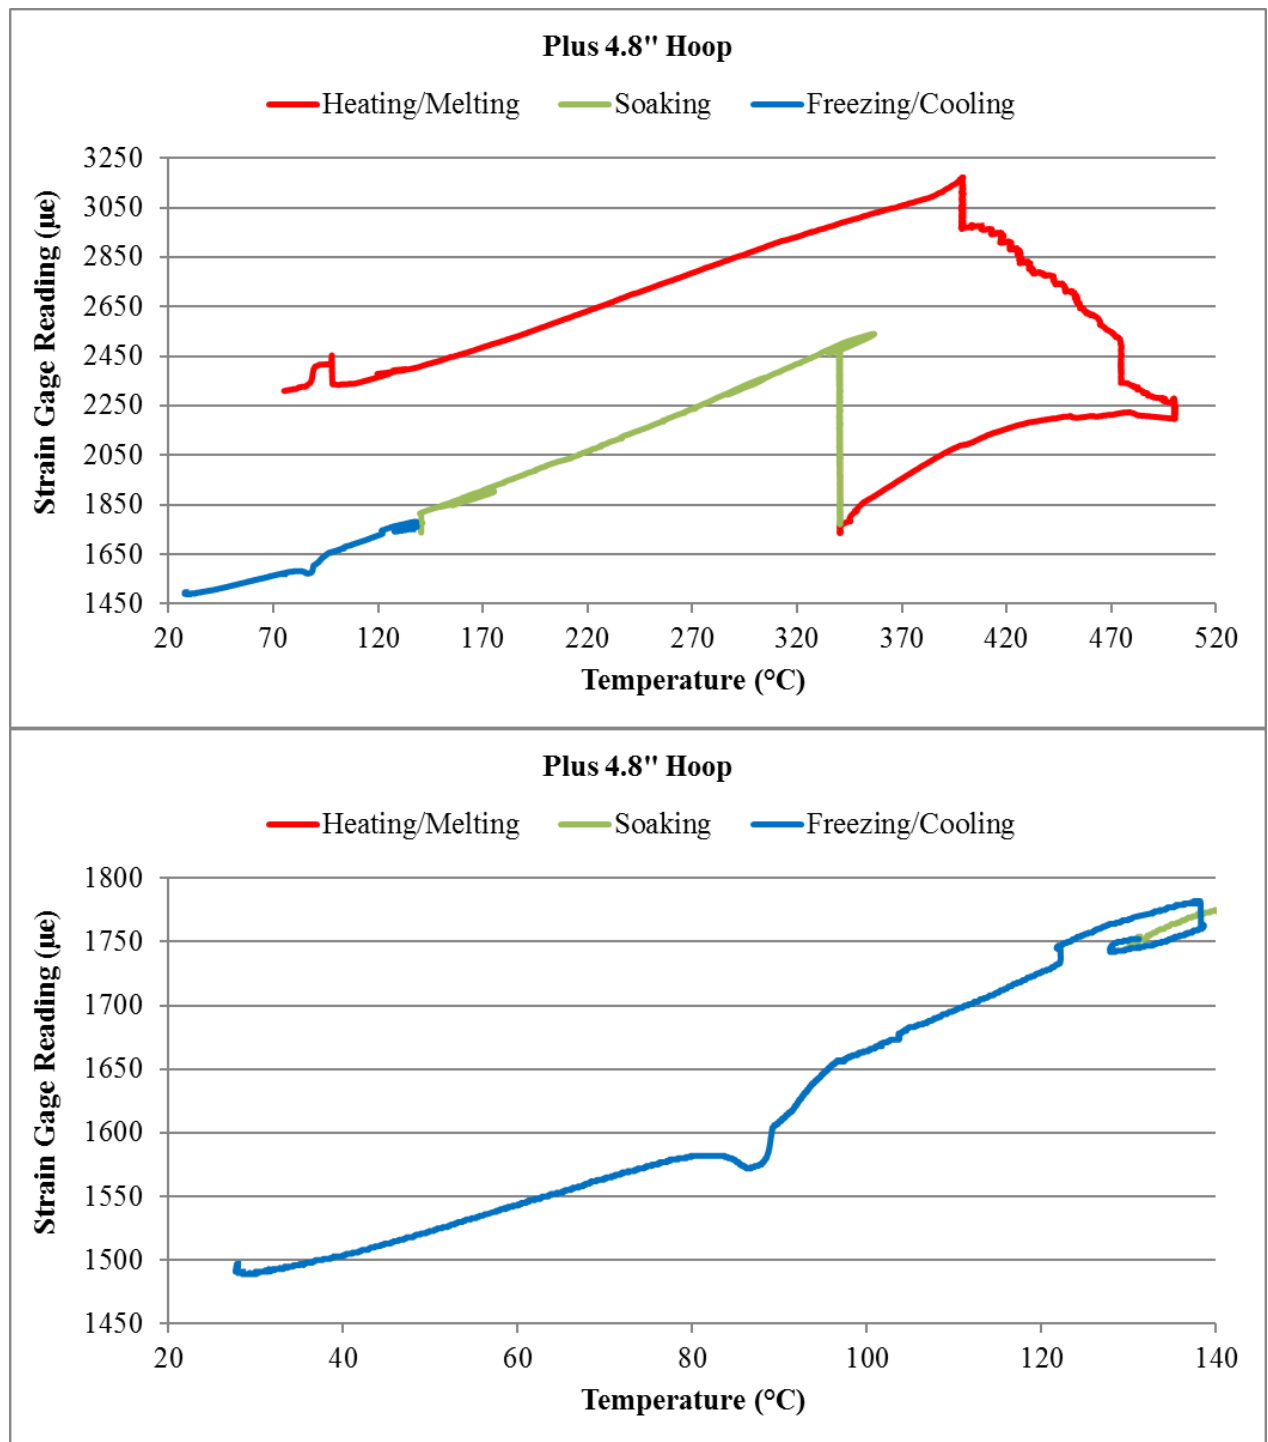
Figure 88. Entire hoop strain history (top) and zoom in of Freezing/Cooling phase (bottom) at +4.8" from the test section center in Test 3.
